Survival Factors

Airbag Safety Study Factual Report

May 20, 2009

Location: Steamboat Springs, CO
Aircraft Type: SR-22
Accident Date: 2/14/09
Accident Time: 1115 MST
Accident Number: N486CD, CEN09LA165
Airbag Equipped: Yes

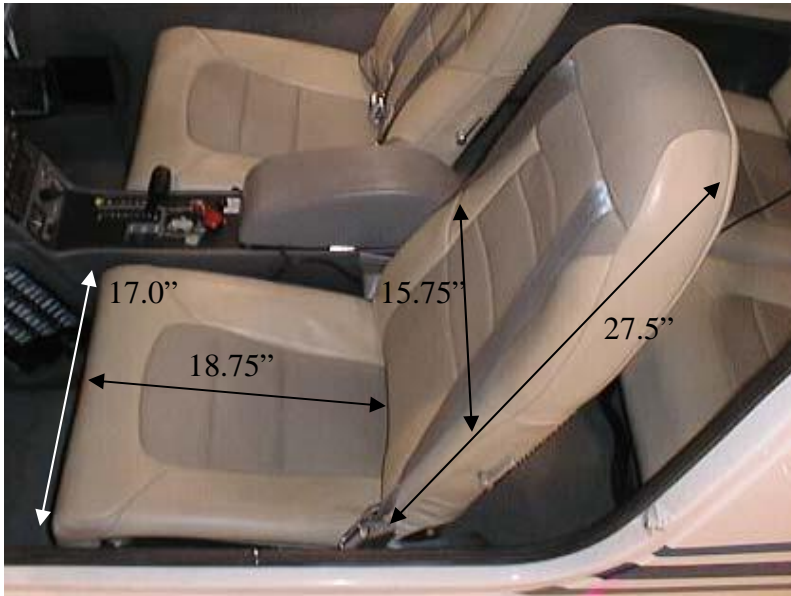
Both left and right front seats measured: seatpan width 17", seatpan depth 18.75", Seatback height 27.5", seatback width 15.75"

Figure 9: Dimensions of the front seat (exemplar photo).

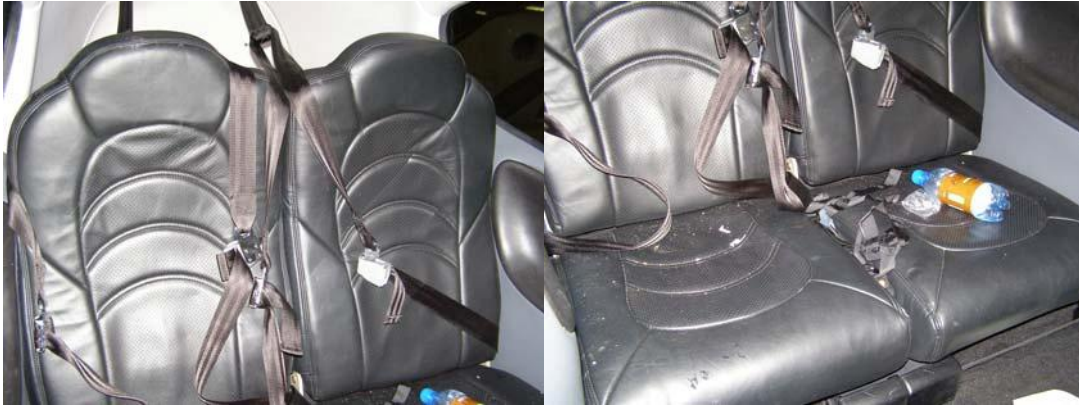
Both left and right back seats measured: seatpan width 18", depth 19", seatback width 19", seatback height 28".

Figure 11 – Rear seats.
